Use Case

Prestressed concrete bridge – Haute-Savoie

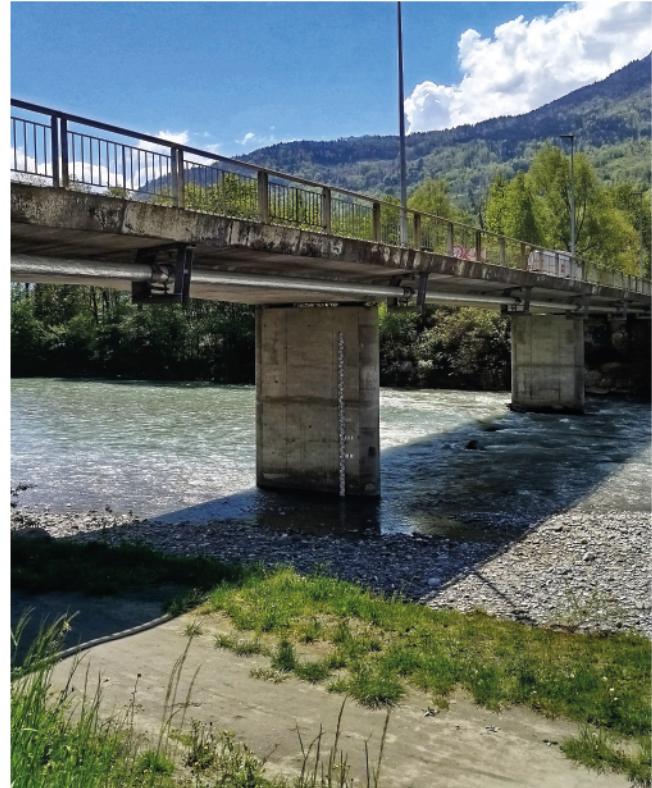
Following an inspection of a prestressed concrete bridge located in Haute-Savoie, a crack considered to be of concern was identified. As there was no previous inspection to determine whether the crack was evolving, an instrumentation system was deployed to characterize its evolution and to define the most appropriate repair solutions.

The mission, scheduled to last two years, requires installation on the underside of the structure, which involves significant maintenance constraints. To limit the costs associated with access (hanging walkways, specific road signage), the choice was made to use a DELTA L+ 100 sensor with a remote reading system.

This solution enables continuous monitoring of the crack opening without the need for regular on-site intervention. The main objective of this instrumentation is to collect the data necessary to define the most appropriate repair works. If the results indicate significant evolution, major reinforcement operations could be considered, with a substantial financial impact for the project owner.
